## Read Discolored Codes

This flyer demonstrates DolphiScan's LOCUS Ultrasound Reader on a discolored Data Matrix. The image shown below (to the right) is generated using the LOCUS Ultrasound Reader with the SoundVision decode software.

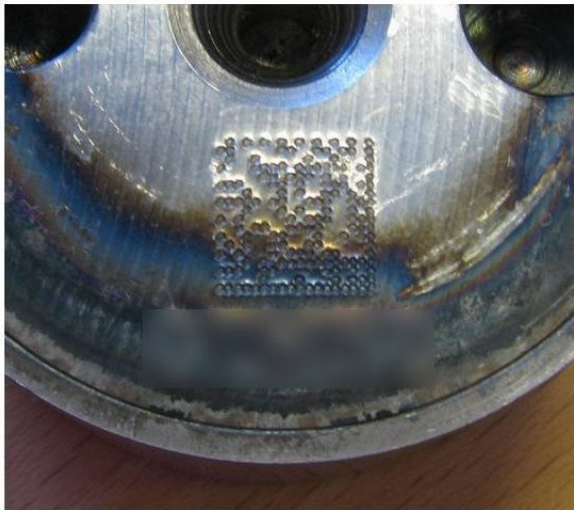
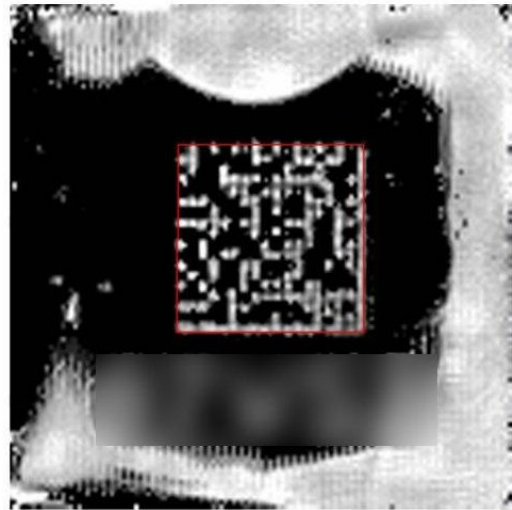
The DMx is marked on a car engine part that has been discolored during curing.

*Discolored DMx on a car engine part*

- DMx size: 18x18
- Cell size: 0.65 mm / 0.026 inches
- Marking method: Dot Peen
- DMx Issue: Discolored during curing
